PROJECT FOCUS

Indoor Pool with Slide & Waterfall

Captures Feel of Tuscany in Elegant Setting

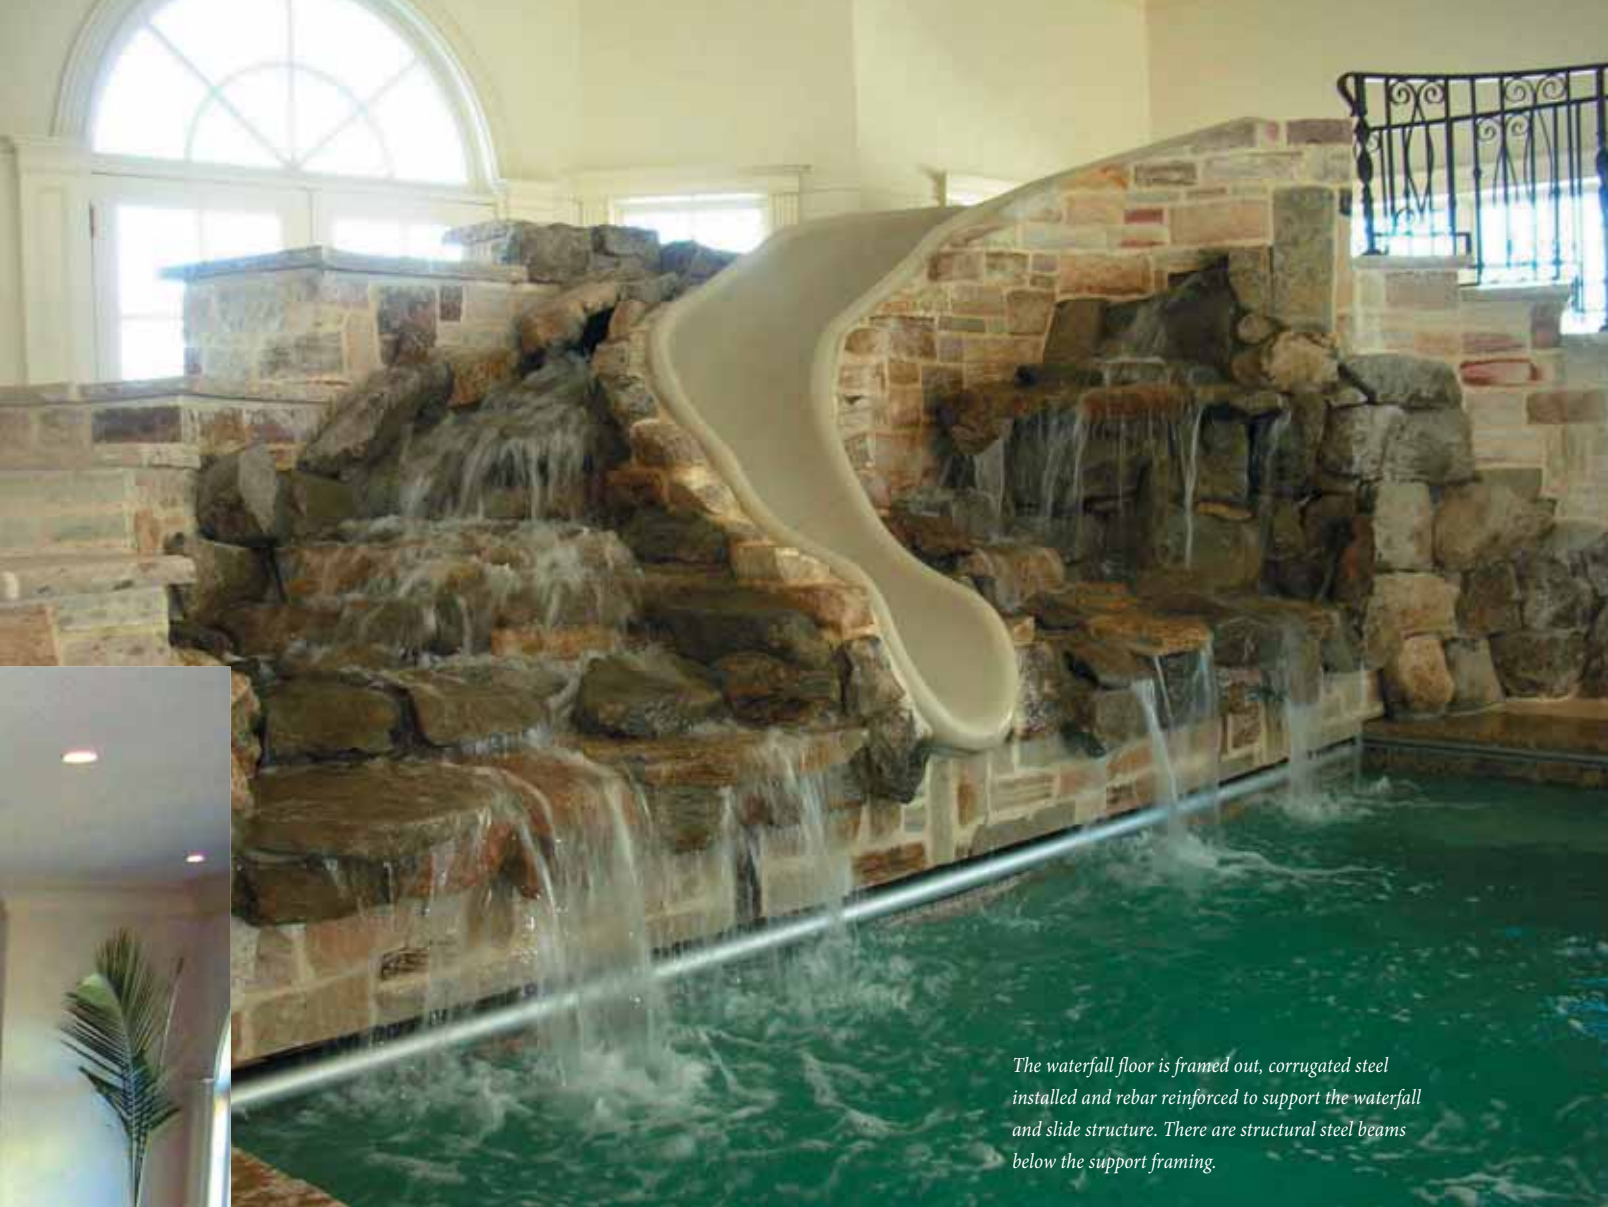
The waterfall floor is framed out, corrugated steel installed and rebar reinforced to support the waterfall and slide structure. There are structural steel beams below the support framing.

This indoor pool is gunite, shot inside of a framed pool room in the pool building. The waterfall and slide area are framed out with corrugated steel and then, reinforced with rebar to support this structure. Structural steel beams are installed below the support framing.
