# West Coast Aerie

*Transforming difficult terrain into an aquatic work of art*

by Jason Cramp

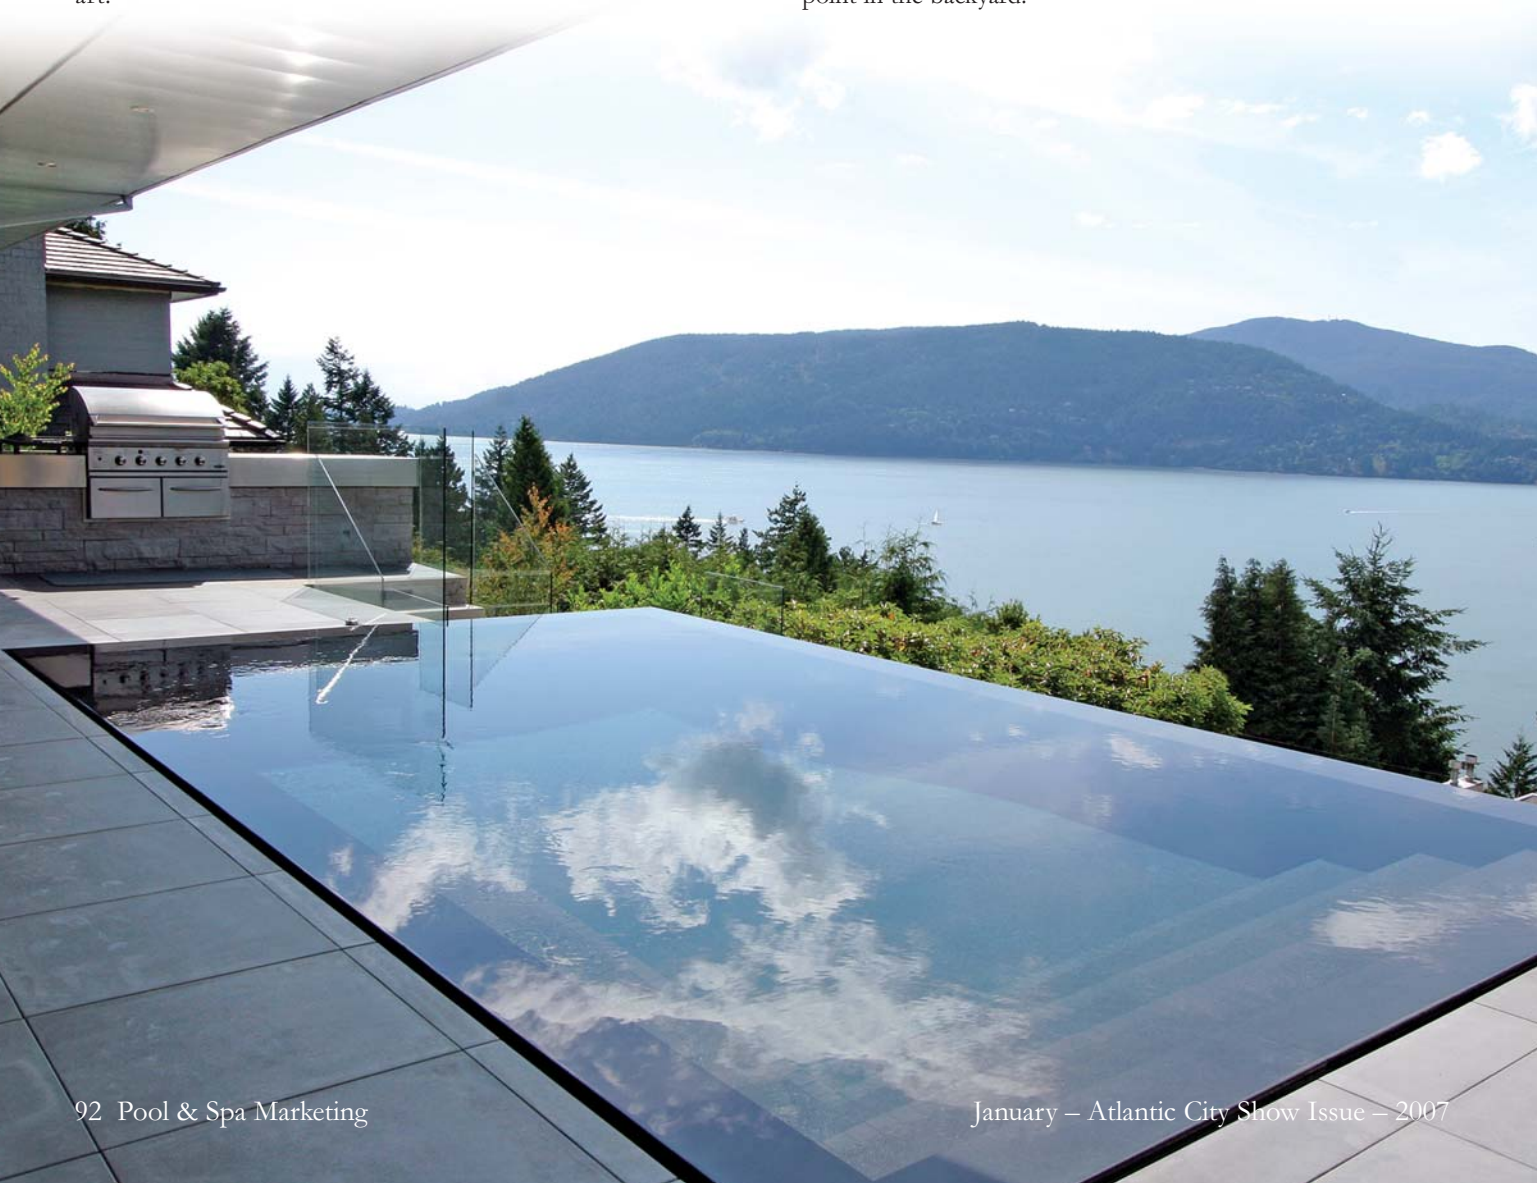
To meet their client's requirements, the project called for a formed and poured above-ground 3 m x 5.6 m (10 ft. x 18 ft. 4 in.) structural concrete swim spa/wading pool.

"The requirements were for a pool to spill over on all sides and incorporate a vanishing edge, with a swim jet system that would not force pool water pass the surface gutter, bearing in mind that the surface gutter is only 2.5 cm (1 in.) wide," explains Alka Pool's Rob Danieli. "We also constructed an underwater seat that spans the entire length of the pool so that the pool owner and their guests could sit in this awesome environment while facing the view."

The unique aspect to the spill-over gutter is the fact that it was designed to sit flush with the patio on two-and-a-half sides and the vanishing edge on the remaining one-and-a-half sides – creating a sheet-glass effect that makes the pool look as though it is constructed of glass, echoing the many other glass elements used throughout the residence.

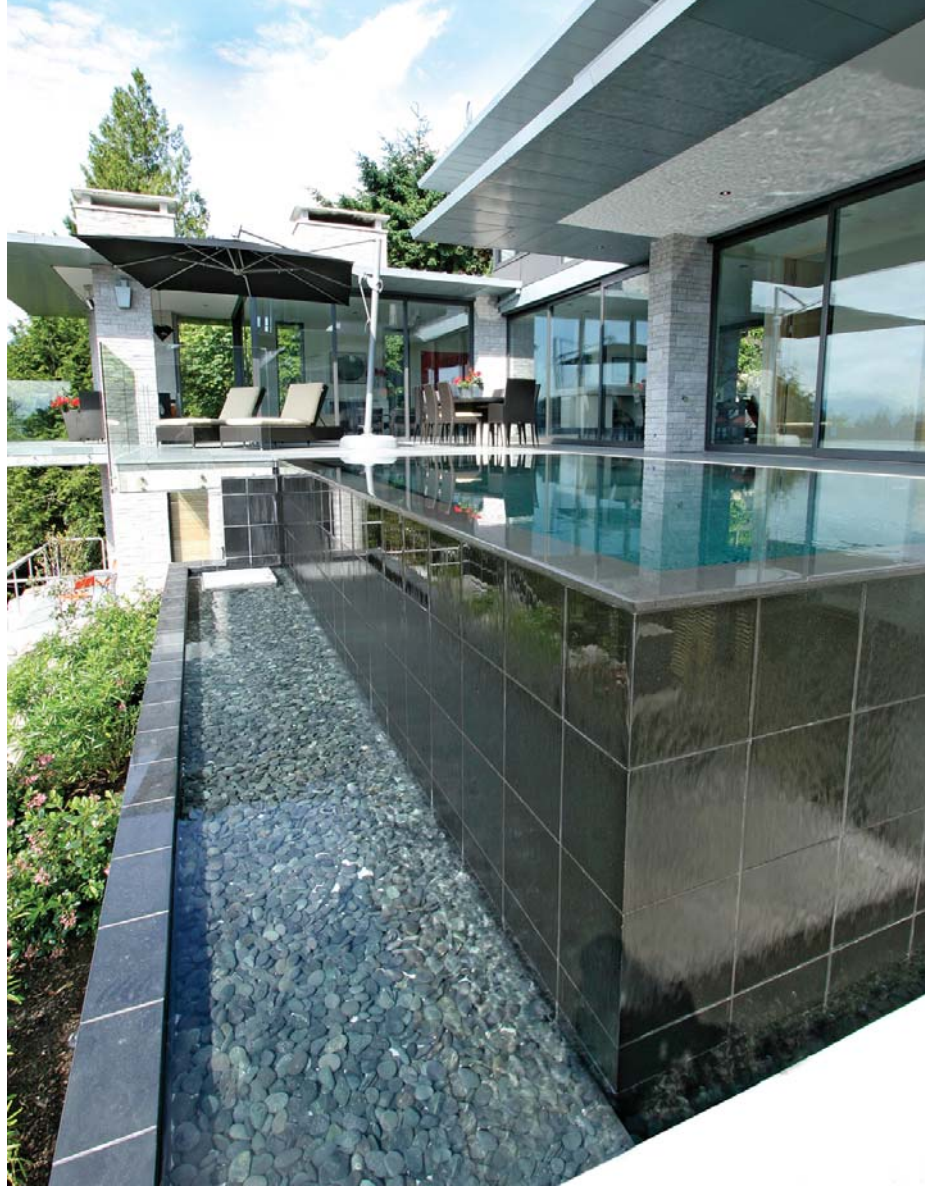
*The waterline and the top of angled ledge are made up of honed black granite with the outer wall of the vanishing edge clad with polished black granite. The catch basin and outer, lower side of the vanishing edge is filled with polished black Japanese stones. The patio that surrounds the swimming pool on two-and-a-half sides is finished in honed Pennsylvania Bluestone.*

"The pool plaster finish is a custom charcoal 3M Colorquartz blend, while the step and seat nosing tile is finished in charcoal 5 cm x 5 cm (2 in x 2 in.) porcelain tile," says Danieli. "The waterline and the top of angled ledge are made up of honed black granite with the outer wall of the vanishing edge clad with polished black granite. The catch basin and outer, lower side of the vanishing edge is filled with polished black Japanese stones. The patio that surrounds the swimming pool on two-and-a-half sides is finished in 61 cm x 61 cm (24 in. x 24 in.) honed Pennsylvania Bluestone, while immediate concrete surfaces are sandblasted.

"The dark tones were designed to give a very precise mirrored look on a calm day as the pool water surface reflects the sky very effectively."
